Failures of Flexible Diaphragm Couplings of Power Take Off (PTO) Shafts of an Aircraft by Surface Discontinuity, Controlled by Stress Concentration or Stress Intensity Factor

Mrityunjoy Hazra and Satyapal Singh

Failures of two power take off (PTO) shafts of an aircraft have been analysed. Two shafts, one each developed by two different manufacturers failed separately during power run endurance test conducted at room temperature and ambient normal atmosphere. In both the cases, cracks were observed on the outer diaphragm disc. One shaft showed cracking in the engine side, while the other one exhibited cracks in the aircraft mounting accessory gearbox (AMAGB) side. Chemical analysis, microstructure and hardness evaluation indicate that the diaphragm material of the shafts is Ti-6Al-4V alloy used in solution treated and aged condition, as per the desired specification AMS 4928. Microstructural in-homogeneity, possibly a result of improper forging, was observed in diaphragm material of both the shafts. Additionally, surface discontinuities induced by forging and subsequent insufficient machining were noticed on the diaphragms. The diaphragms failed by fatigue with cracks possibly nuc

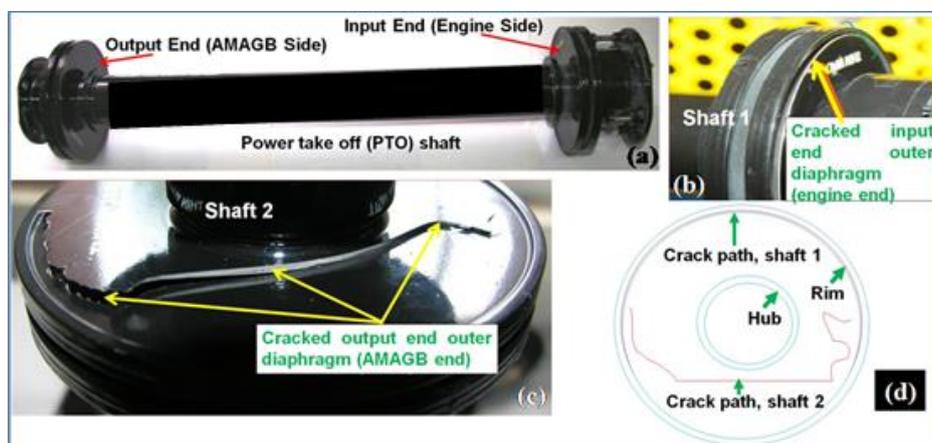
Pictures of as-received PTO shafts are shown in Fig. 5. In case of shaft 1 (Fig. 5a), cracks were observed on the diaphragm disc at the engine side, i.e. close to the input end. In shaft 2 (Fig. 5b), cracks are observed on the diaphragm disc at the AMAGB side, i.e. close to the output end. Fig. 5c displays position of the crack on the diaphragm discs, schematically for both the shafts. In shaft 1, the crack covers almost 2/3rd of the circumference of the rim section. In shaft 2, crack propagates almost rectilinearly in the vicinity of hub. It also covers the periphery region near the rim.

Fig. 5: As-received failed power take off (PTO) shafts – (a) general view, (b) shaft 1, (c) shaft 2, (d) schematic diagram showing the location of crack on diaphragm disc in the failed shafts.

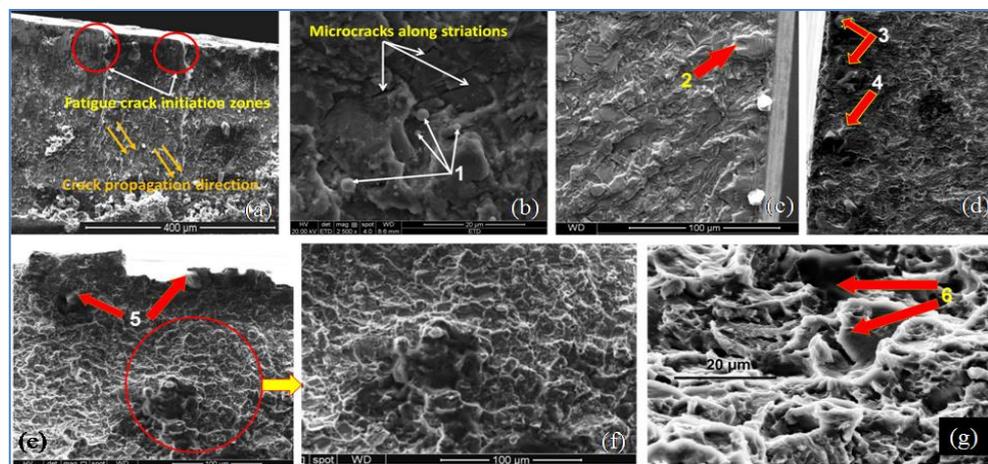
Fractographs of the failed pieces of the diaphragm are shown in Fig. 6. Striations marked by downward arrow in Fig. 6a indicate that the component has failed by fatigue. The striations are also associated with micro-cracking (Fig. 6b). Fracture origin could not be identified due to severe rubbing on major portion of the fracture surface. Presence of particulate material, spherical and irregular shaped, was seen. The EDS results on the said features are given in Table 3. Particles 1 and 2 (Fig. 6b,c) are oxygen enriched base metal with little bit of iron. On the other hand, particle 3 reveal composition of the base metal, while 4 contains Na, Ca, Si and Cl in the oxygen enriched base metal. Fractographs of other local regions (Fig. 6e-g) display ductile overload failure. In this case, the particles (5 and 6) are iron and/or oxygen rich.

Fig. 6: Fractographs of shaft 1at different locations – (a-d) fatigue fractured regions, (e-g) overload failure.

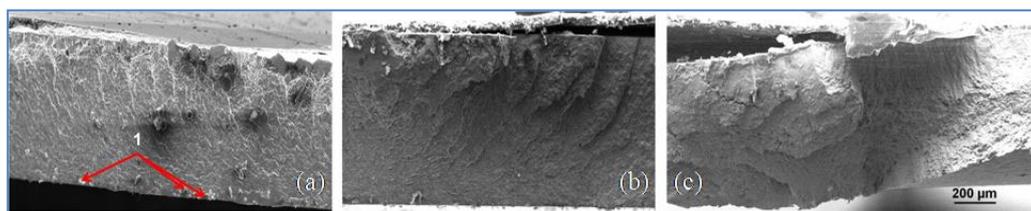
Fractographs are shown in Fig. 7. Well defined fracture features were seen in few locations on fracture surfaces, while major parts were severely rubbed. As a result, fracture origin could not be identified. Presence of fatigue striations with multiple origins is seen in Fig. 7a,b. Overload features are shown in Fig. 7c. Particulate material (1 in Fig. 7a) containing Na, Ca, Si, Cl with oxygen enriched titanium product was noticed (Table 3). However, the fracture surface was quite clean with respect to the presence of particulate material, unlike that was observed in case of shaft 1.

Fig. 7: Fractographs of shaft 2at different locations – (a,b) fatigue fractured regions, (c) overload failure.

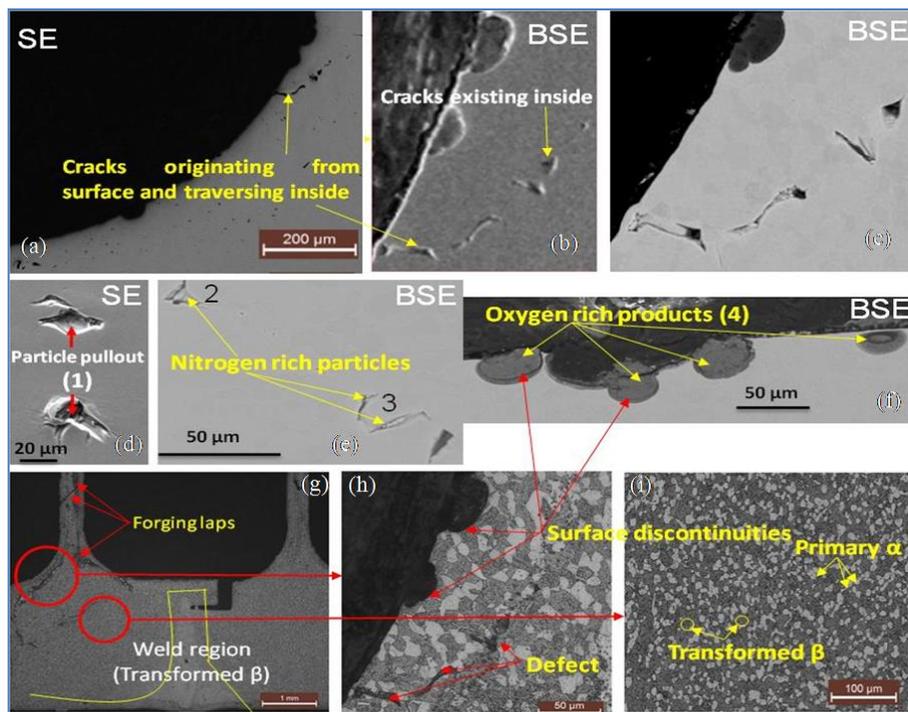
Representative unetched SEM images (secondary and back scattered) of the diaphragm cross sections for both the shafts are shown in Fig. 8. This is taken from the rim region and it does represent microstructure of the other regions as well. Chain type of defects originating at surface often traversed inside as shown in Fig. 8a-c. Interior cracks of the same chain type of appearance as well as particle pull out were noticed (Fig. 8b-d). Both the surface as well as interior chain type of defects revealed composition of base metal, while EDS was carried out. Si and C have been found to be present in the region of particle pull out (point 1 in Fig. 8d, Table 3). Nitrogen rich inclusions were found in the interior of the sample (points 2 and 3 in Fig. 8e, Table 3). Surface discontinuities were observed throughout the diaphragm cross section, as is shown in Fig. 8f,h. Products rich in oxygen and titanium along with significant amount of Na, Ca, K and Cl were found within those discontinuities as well as at few sub-surface locations (point 4 in Fig. 8f, Table 3). Etched micrographs are shown in Fig. 8g-i. Equiaxed α plus transformed β microstructure was observed throughout the base regions (away from the weld), while the weld region revealed presence of transformed β . Chain type of feature in the interior as well as on the surface with composition near to the base metal composition was well revealed after etching (Fig. 8g,h). In case of shaft 2, frequency of occurrence of both the surface discontinuities as well as nitrogen rich inclusions were quite lower as compared to those in case of shaft 1. Bulk elemental composition of the diaphragm disc material for shafts 1 and 2 are as given in Table 4.

Fig. 8: Scanning electron micrographs of the rim portion of a typical outer surface cross-section of an outer diaphragm disc in SE and BSE modes - (a-f) unetched micrographs showing various defect types, (g-i) etched micrographs revealing forging laps more clearly. Etchant: Kroll's reagent.

These defects are acting as stress concentrators during testing as the torque is transferred from engine to aircraft mounting accessory gear box (AMAGB) and have originated the failure. The cracks have preferentially nucleated at those regions and the propagation occurred by fatigue as seen by striations and microcracks.

- i. Surface discontinuities are most likely to have initiated failure of the diaphragm discs of both shafts.
- ii. Lower frequency of occurrence of surface discontinuities in the diaphragm material of shaft 2 might have resulted in its somewhat increased life (466 million cycles) as compared to that of the diaphragm of the shaft 1 (104 million cycles).
- iii. Controlling factor triggering the failure of diaphragm of shaft 1 seems to be the available high stress level along the rim periphery, while that for shaft 2 is presence of few localized sharp surface discontinuities.
- iv. Surface discontinuities causing the failure are result of high temperature forging and subsequent insufficient machining.

- i. Microstructural characterization of the starting blank should be carried out to detect the presence of surface irregularities, nitrogen/oxygen rich inclusions, forging lap, microstructural banding and chunky alpha. The same should be also done on the forged blanks, before final machining. All forgings as well as finished and ready to assemble discs should undergo ultrasonic flaw detection test as per AMS-2631 Class A (2mm FBH) and need to be certified by airworthiness certifying authorities [15].

- ii. The starting blank for forging the Ti-6Al-4V diaphragm discs should be judiciously thicker (at least 2 mm thicker than that was used in present case). This is to ensure that those types of undesired defects present on and near to the surface after forging are removed completely during subsequent machining.

- iii. The product should be free of any oxygen-rich layer such as alpha casing, or other surface contamination, determined by microscopic examination. In this regard, the approved and identified feed stocks may be coated with suitable temporary coatings prior to transit or during storage.

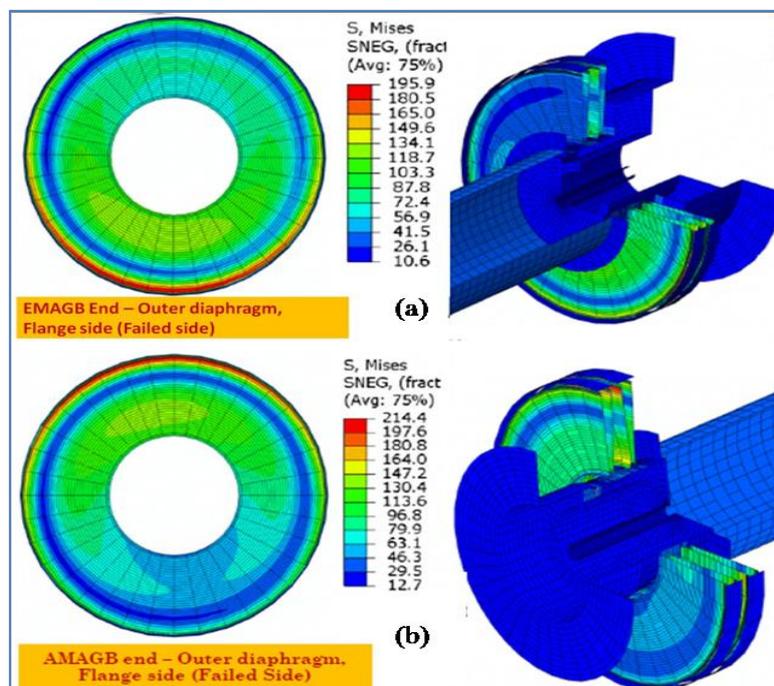
Probable stress patterns developing on the diaphragm discs were determined by the finite element method (FEM) of analysis. The pattern developed on the failed diaphragm discs on engine side (for shaft 1) and AMAGB side (for shaft 2) under the combined action of misalignments, peak operating torque and centrifugal forces are shown in Fig. 10. Maximum stress level was found to exist along some portions of the rim periphery (covering the periphery around 50%) in both the cases. However, very low stress level is obtained in one location near the hub for the failed diaphragm of shaft 2.

Fig. 10: Stress patterns developed on the failed diaphragms of the PTO shafts under combined actions of misalignments, peak operating torque and centrifugal forces - (a) EMAGB (engine) end outer failed diaphragms, (b) AMAGB end failed outer diaphragm.

Maximum stress values exist along the rim periphery of both the failed discs, as was shown in Fig. 10. This is probably due to the existence of highest stress concentration regions along the rim periphery because of the presence of thinnest diaphragm sections along with sharper (lower) fillet radius. However, failure initiation of only one diaphragm (that of the shaft 1) was along the periphery and it failed along the periphery. On the other hand, failure of the other diaphragm seems to have originated at a region between rim and hub of the diaphragm. This is supported by the (presence of a smooth linear path along major portion of the) crack profile, although origin could not be identified due to severe rubbing. Interestingly, there is a region of low stress in between rim and hub of the diaphragm disc of shaft 2, as shown in Fig. 10b. Probably, different origins of the failure of the diaphragm material of similar microstructure may be attributed to the location of attainment of the critical stress intensity factor (K_{Ic} , i.e. fracture toughness). Failure origin is that region wherein crack of considerable width and length is developed to make the failure event complete by attaining the K_{Ic} value. Now, value of stress intensity factor (K) in presence of a crack and/or discontinuity depends on both the available stress level (σ) and notch dimension (a) by the equation:

concentrated rim periphery, while that for shaft 2 is presence of few localized sharp surface discontinuities. This indicates that stress concentration effect dominates the failure of shaft 1, while the dimension of surface discontinuity and so time to reach stress intensity factor (SIF) controls the failure of shaft 2.
