Failure Analysis of Stainless Steel Lanyard Wire Rope

Aginaparru Sambasiva Rao and Ashok Kumar Singh

ABSTRACT

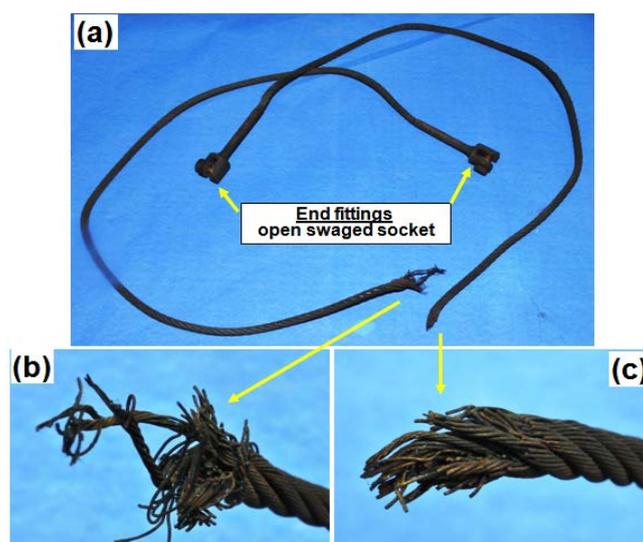
The broken wire rope in as-received condition is shown in Figs.1 (a-c). Wire rope is made up of seven strands and each strand comprises 19 wires (rope length: 3 feet 6 inches). This displays dark brownish colour. The wire rope supplied with two broken ends (Fig. 1a). This consists of many small diameter wires wound together into strands and then these strands are knit jointly into a wire rope. The end fittings of the wire rope are festinated with open swaged socket. Broken end region displays several wires unwound and loosen from their strands (Fig.1 b, c).

Figure 1: Photograph of failed wire rope: (a) as-received condition, (b) one end of the broken rope, (c) another end of the broken rope displays several wires unwound from its strands and loosens from their strands.

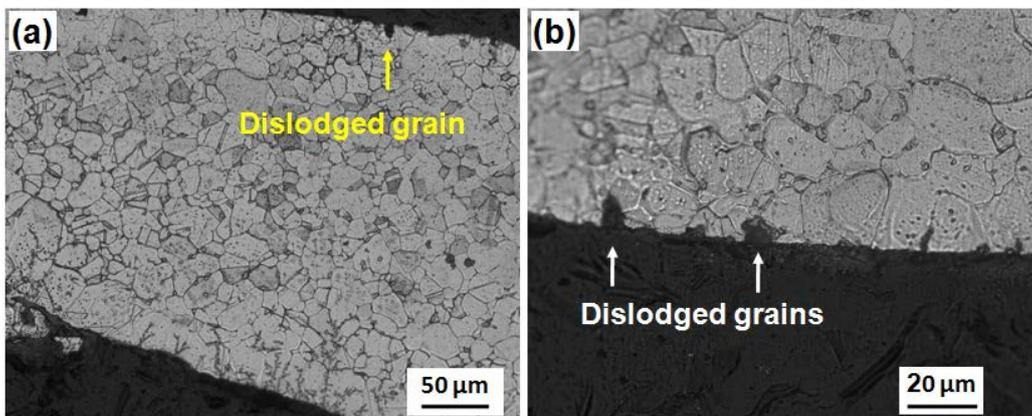
Optical microstructures of the wire rope are shown in Fig. 2. This displays the presence of typical equiaxed austenitic grains along with annealing twins (Fig. 2a). The grain size near and away from failed appears to be same. Very close to the fractured area, the microstructure exhibits extensive material degradation due to grain boundary weakening. The several pieces of material consisting of a few grains are dislodged from the periphery of the individual broken wire by breaking along grain boundaries (Figs. 2b). BSE image close to the fracture obtained in un-etched condition exhibits continuous thin film along grain boundaries (Fig. 3). This observation is analogue to the optical microstructure (Fig. 2). The X-ray elemental mappings of O, Cl, Cr, Ni and Mn elements of failed wire rope in un-etched condition obtained by EPMA are shown in Fig. 4 (a-f). Elemental distribution mapping reveals that the grain boundaries are enriched with Oxygen, Chlorine and Chromium Fig. 4 (b-d). On the other hand, uniform distributions of Nickel and Manganese are observed in the matrix Fig. 4 (e-f).

Figure 2: Optical micrograph of failed wire rope shows (a) austenite grain structure with few dislodged grains from the grain boundaries at the surface near fracture and (b) high magnification of Figure a.

Chemical composition of the wire rope indicates that the wires are made using austenitic stainless steel AISI 304 grade (Table 1). Presence of annealing twins within the equiaxed austenitic grains indicates that the wire rope is used in annealed condition (Fig. 2a). This also suggests that the rope wires are initially prepared by wire drawing and subsequently annealed. The optical microstructure of the wire exhibits two features namely (a) overall grain size is nearly uniform from centre to periphery and (b) several cracks along the grain boundaries at the periphery of the wire rope. In addition, parts of material consisting of several grains have been dislocated from the wire (Figs. 2 b). The dislocated materials have broken from the wire along the grain boundaries. This clearly reveals that the grain boundaries have significantly weakened during service.

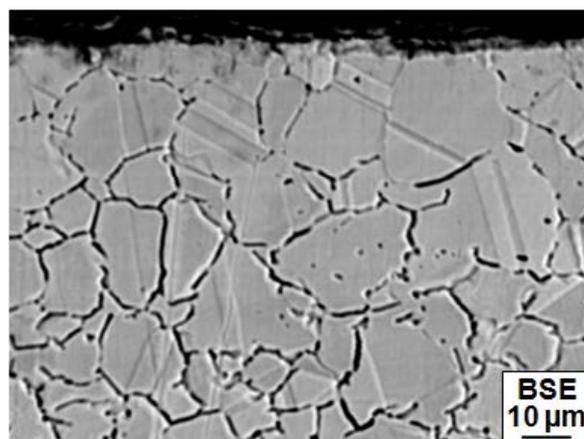
Figure 3: BSE microstructure of the individual wire near failed end showing dislodged grain structure at the surface and dark network along grain boundaries.

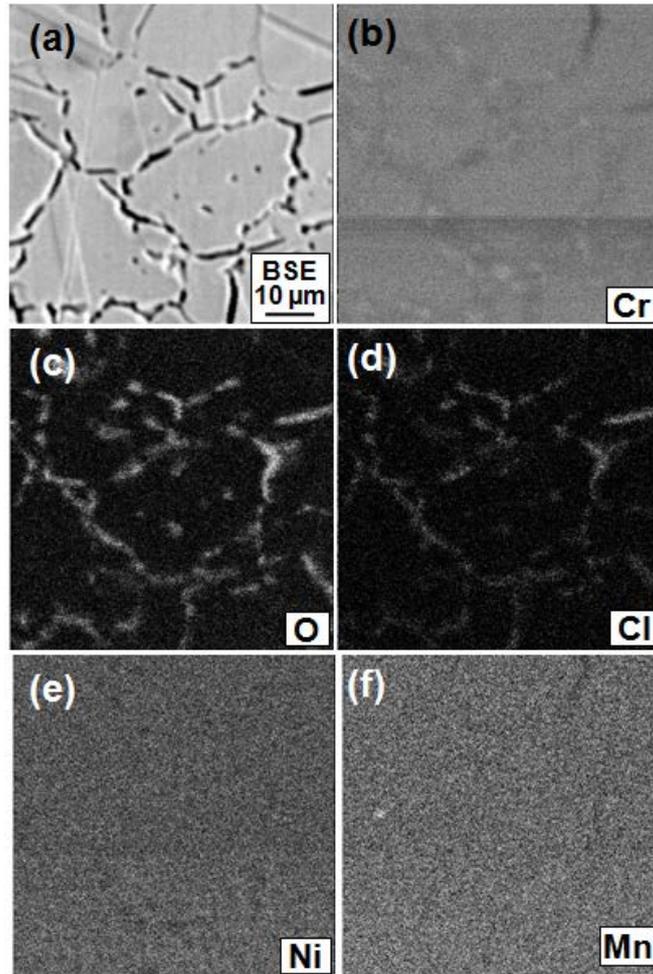
Figure 4: (a) BSE micrograph and X-ray elemental distribution mappings: (b) Cr, (c) O, (d) Cl, (e) Ni and (f) Mn obtained by EPMA technique.

The BSE micrograph of un-etched samples resembles similar features to that of the optical microstructure. EPMA X-ray elemental mappings reflect that grain boundaries are enriched with Cl, O and Cr (Fig. 4). The weakening of grain boundaries along with dislodged materials from the periphery of the wire therefore indicates that the rope is exposed to corrosive environment during the service. Presence of Cl and O at the grain boundaries in the form of thin film supports the same. In addition, the periphery of the individual wire is also surrounded by thick continuous layer of the corrosive debris (Fig. 6 a-d). Fracture surfaces of the failed rope have shown the presence of corrosion debris which in fact has masked the actual fracture (Fig. 6). The EDAX spectrum of the fracture surface also supports the presence of Cl and O (Fig. 7). All the wires in the failed rope have shown similar behaviour.

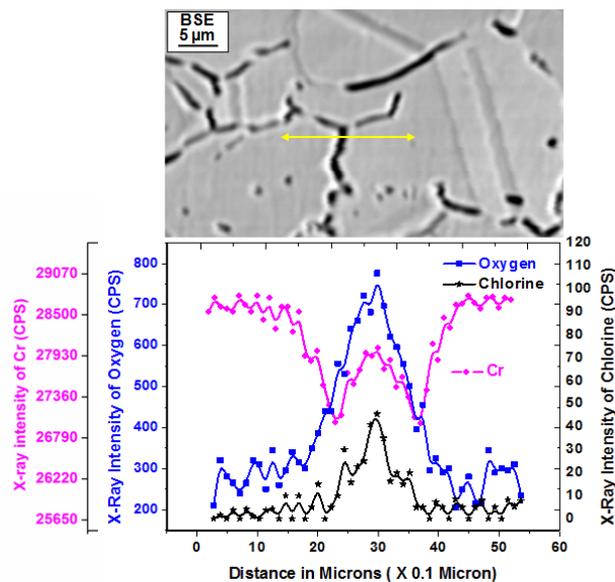
In order to confirm these results, X-ray line scan technique has been employed for Oxygen Chlorine and Chromium elements and results are shown in Fig. 5. This reflects evidently that the line scan profiles have validated the enrichment of Oxygen, and Chlorine at the grain boundary. Line profile has also displayed the chromium enrichment at the grain boundary as well as the depletion at either side of the grain (i.e. at the vicinity of grain boundary). The fracture surfaces of failed wire rope near the actual fractures are shown in Figs. 6 (a-d). Thick layer of foreign material deposition is exhibited over the fracture surface of the individual wires and all around the surface of each wire. The fracture surfaces of the wire appear to be rough and the individual wire does not show distinctive mode of fracture features. These are similar to mud cracks with oxide layer (Fig. 6 b-d).

Figure 5: EPMA Line profile of the elements O, Cl and Cr across the grain boundary demonstrates as reflected in the X-ray mappings.

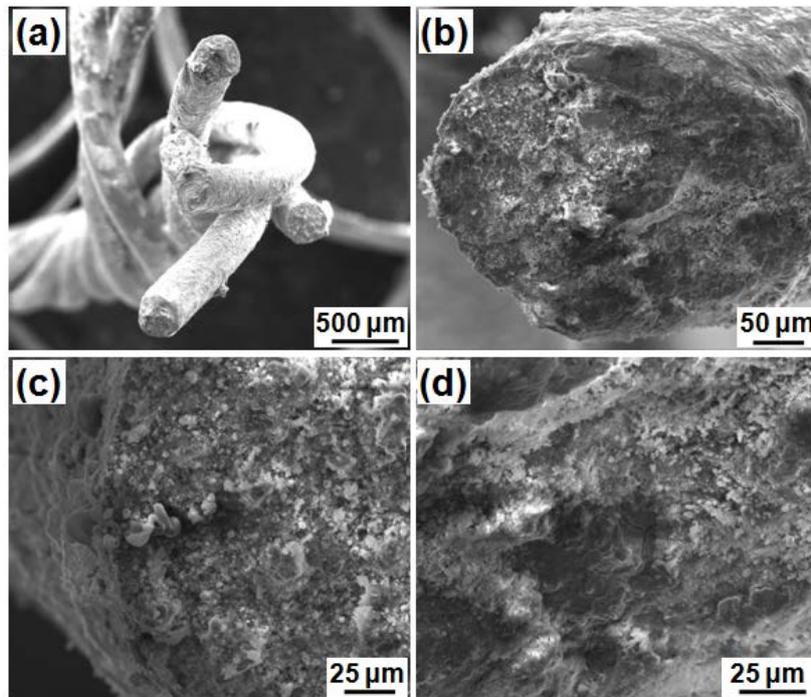
Figure 6: SEM fractographs of individual failed wire obtained at (a) Low magnification and (b-d) high magnification show thick layer deposition of corrosion debris over the fracture surface.

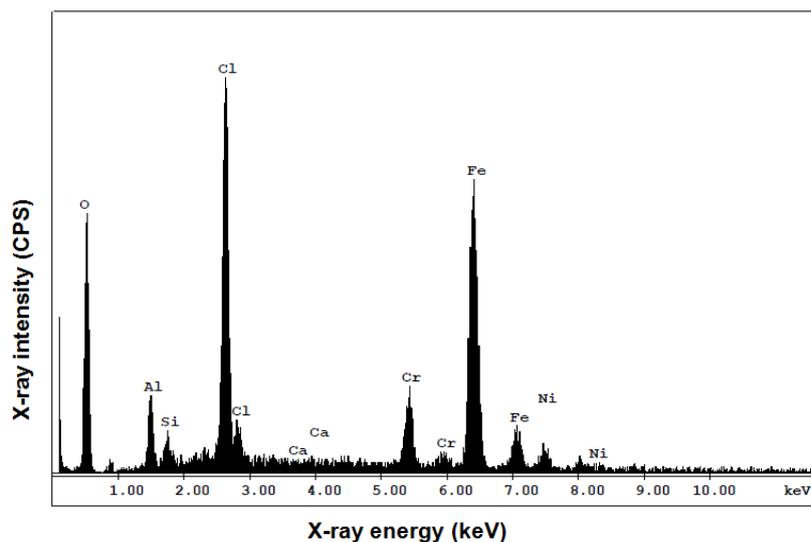
EDAX spectrum taken on fracture surface of the failed rope near the actual fractures has revealed the presence of chlorine and oxygen in addition to matrix elements (Fig. 7). These results are well agreement with those obtained by EPMA analysis (Fig. 4 and 5). Tensile properties of failed, used (but not failed) and unused wire ropes are summarized in Table 2. It clearly shows that the load bearing capacity of the failed wire has reduced nearly 1/4 and 1/2 times of the unused and used wires, respectively. The ultimate tensile strengths of the wires reported in Table 2 also support the same. The fracture surfaces of tensile tested specimens of the failed and unused wires are shown in Figs. 8 and 9. The flat fracture with no reduction in the cross sectional area is seen in the failed individual wire (Fig. 8a).

Figure 7: EDAX Spectrum taken from the fracture surface of the failed individual wire exhibits presence of O and Cl in addition to matrix elements.

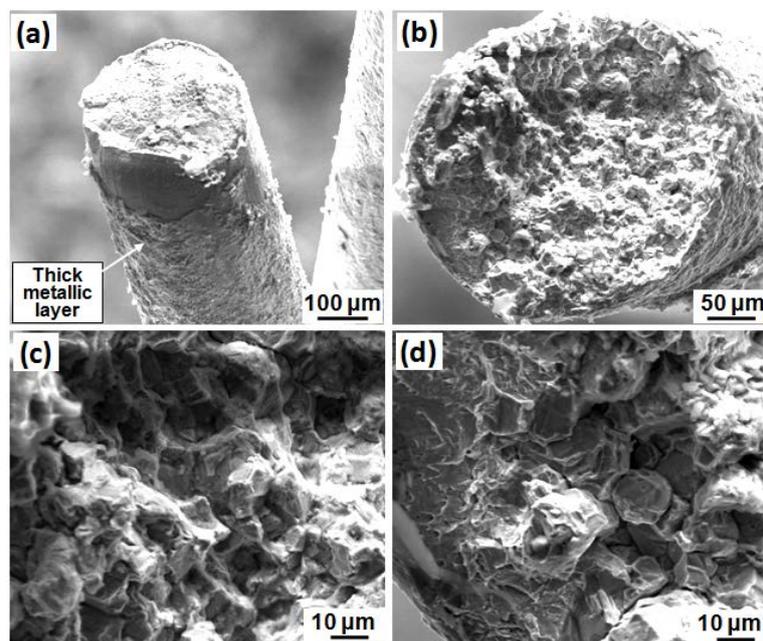
Fracture surface of tensile tested wire of the failed rope displayed a thick metallic layer covered around the circumference of the failed wire. However, a part of the thick layer of the individual wire has fallen away from close to tensile fracture during tensile deformation (Fig. 8a). The fracture surface of the wire appears to be rough and clearly reveal the presence of intergranular fracture (Figs. 8 (c and d)). The tensile fracture surface of the unused wire exhibits smooth surface finish around the rope outer surface (Fig. 9a). The fracture features displays sufficient necking indicating typical ductile mode of failure (Fig. 9b).

Figure 8: SEM fractographs of tensile tested failed wire rope: (a) low magnification and (b-d) High magnification reveals flat fracture with intergranular mode of failure.

Tensile tested fracture surfaces of the unused wires display entirely different features (Fig. 9) than that of the failed wires in terms of mode of failure (Fig. 8). The failed wire exhibits typical intergranular fracture in spite of the presence of corrosive debris. In addition, this also shows the presence of thick layers around the periphery (Fig. 8a). On the other hand, fracture surfaces of unused wire rope exhibits smooth surface finish around the rope outer surface (Fig. 9a). Unused wire rope has undergone significant necking before tensile failure and finally failed in ductile mode. This clearly suggests that the wire rope has slowly deteriorated during service and then suddenly failed with intergranular fracture mode. It appears that the crack propagated along the weak grain boundaries during tensile test and finally failed in intergranular mode (Fig. 8).

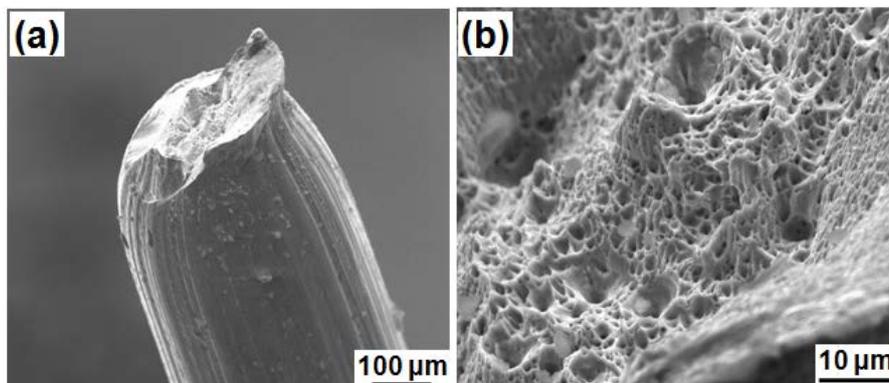
Figure 9: SEM fractographs of tensile tested unused wire rope: (a) low magnification (b) high magnification showing considerable reduction in size with dimple mode of fracture.
