Failure Investigation on Failed Towing Arm of an Aircraft: A Case of Improper Material Processing and Failed Repair Welding of a Cast Al-Cu-Si Type Aluminium Alloy

Mrityunjoy Hazra and Ashok Kumar Singh

M. Hazra ✉, A. K. Singh
Defence Metallurgical Research Laboratory (DMRL)P.O. Kanchanbagh, Hyderabad 500 058, India
E-mail: mhazra@dmrl.drdo.in

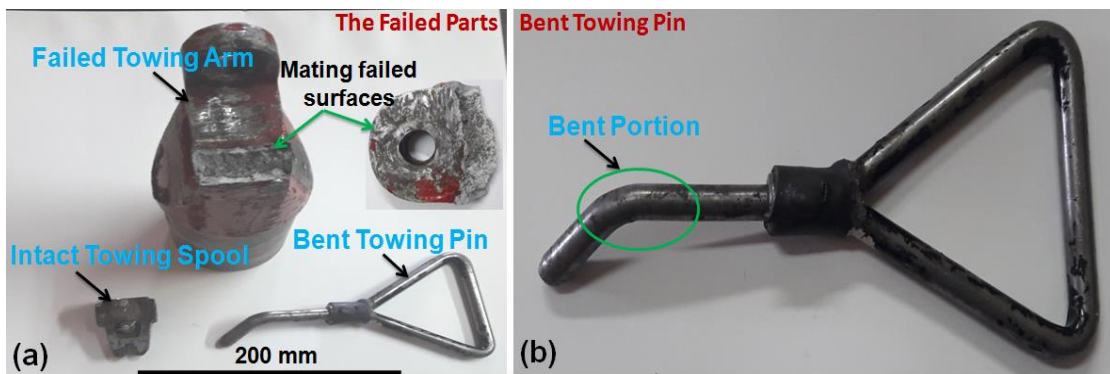
As-received failed components are shown in Fig. 2. Fractured towing arm fork end bent towing pin along with intact (undamaged) towing spool are seen. Red colour paint is seen to cover the entire towing arm fork. Fig. 3 reflects fracture surfaces of towing arm fork end in various views. Typical brittle fracture of as-cast products seems to prevail, as is typified by coarseness of the fracture features. There is existence of well revealed weld regions in the surroundings of the fracture surfaces. Probable detached/peeled off parts during service which seem to have been welded later on have been marked (Fig. 3(d, e and f)). These are quite easily identifiable by visibly clear weld beads (boxed). Clear visibility is obvious for weld region, base material as well as the heat-affected zone (HAZ) on the failed surfaces (Fig. 3 (a, b and c)). A prominent secondary crack spanning across the whole fracture surface and almost at boundary

Figure 2: Photographs of the as-received broken towing arm fork and bent towing pin

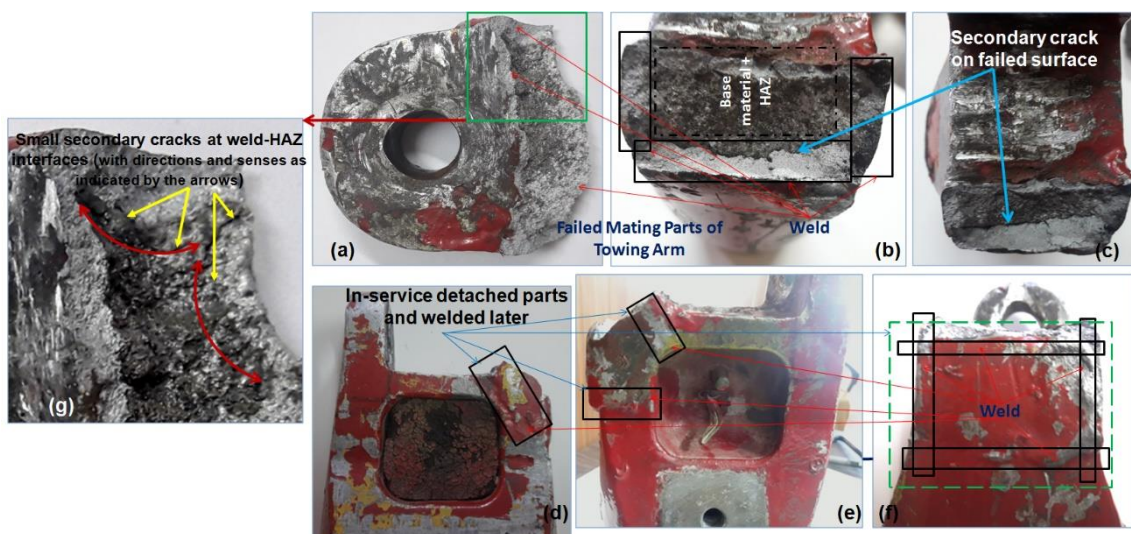
(fusion line) between the weld region and the rest of the cross-section (consisting of HAZ and base material) is seen (Fig. 3 (b and c)). Also, the mating failed surface reveals some small secondary cracks at the welds close to the boundaries of weld and HAZ in two perpendicular sides (in 2-dimension) of the failed component (Fig. 3g). These cracks are along the weld-HAZ boundary at one side weld as well. Henceforth, weld regions with bigger and smaller dimensions at two perpendicular directions are referred as longitudinal and transverse welds, respectively. The counterpart of the fracture surface presented in Fig. 3a is shown in Fig. 3h. This is a magnified view of high resolution of the portion presented in Fig. 3b. Here, one may notice the disparity between weld thicknesses in longitudinal and transverse welds.

Figure 3: Photographs of fracture surfaces of towing arm fork end in various views

It seems that the repair welding has been carried out to refurbish prior localized failed and detached areas (Fig. 3a). However, one must notice that the inherent defects in the base material in present case are the cracks along the grain boundary precipitates in addition to the pores and grain fallouts. Thus, the avoidance of recurrence of such failure by repair welding is not possible, unless it changes the local thermal and/or chemical history to the desired extent [13-17]. Intended microstructure resulting from this proposed change in local thermal and/or chemical history may find usefulness in such case. However, no such desired changes have been observed in present case, after the T6 heat treatment given to the whole assembly (base material + weld). Interestingly, weld material has been found to contain more defects in terms of pores and cracks than the base. Therefore, adoption of the method of repair welding does not seem to suit the purpose of mitigating the existing defects in base material, also assuming that some of those defects have been responsible for the failure.

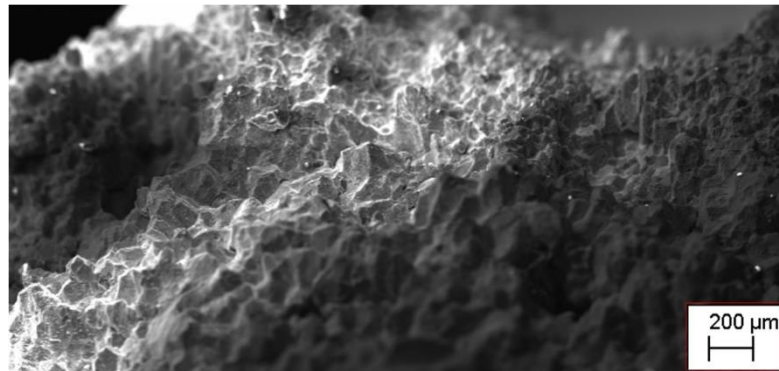
Fractographs are presented in Figs. 4-7 along with EDS analyses. Intergranular fracture features have been found to be prevalent. Fig. 4 displays low magnification image showing intergranularity of the fracture surfaces. Figs. 4 and 5 (a, b and c) represent fracture features from HAZ (marked in Fig. 3b). On the other hand, representation of weld fracture is in Fig. 5d. Summary of all the types of fracture features observed at various locations on the surface is presented in Fig. 5. Gas-hole and/or porosity have been observed occasionally (boxed region in Fig. 5a). Intergranular fracture features is quite noticeable along with shallow rubbing. Deep secondary cracks along the intergranular channels have been observed (Fig. 5 (c and d)). Interestingly, this fracture feature also resembles the appearance of pores (Fig. 5c). It is to be noted that the type of intergranularity differs in features presented in Fig. 5(b and c) to Fig.5d. Signature of cleavage within the intergranular fractures has also been noticed occasionally (Fig. 5 (c and d)). Intergranularity in fracture is more vivid in a location presented in Fig. 5d, in contrast to the rubbed intergranular fracture of the few other locations observed in Fig. 5c.

Figure 4: Low magnification SEM image of fracture surface

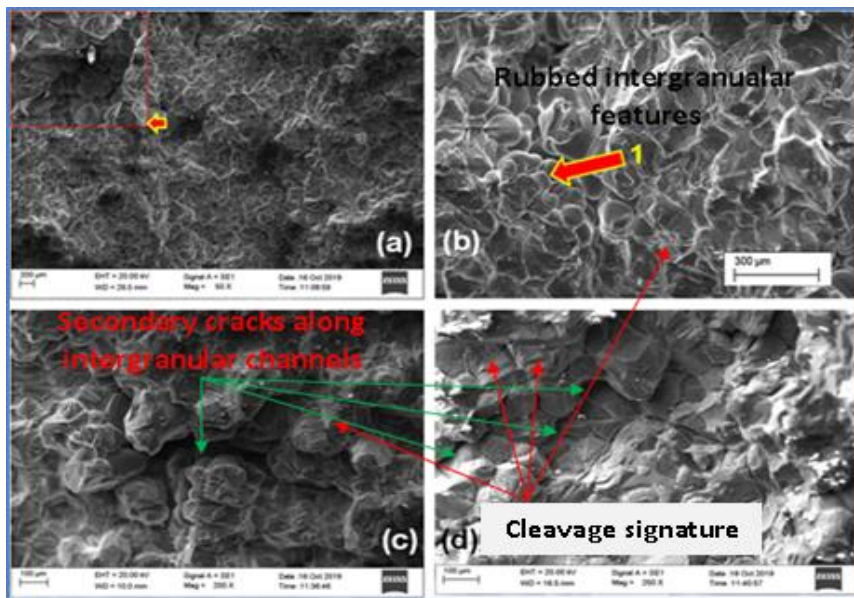
Figure 5: Summarized view of the various types of fractures observed in the present failure

Longitudinal weld side in the final failure reveals the presence of cleavage signs with occasional occurrence of cleaved facets within the moderately well revealed predominantly intergranular fracture (Figs. 5 and 7). On the other hand, clear disclosure of the cleavage signature along with cleaved facets and faintly revealed two-dimensional intergranular channels have been noticed on the transverse weld side during the final stage of failure. Thus, predominance of traits of cleavage fracture has been noticed especially along the transverse welds unlike along the longitudinal welds. Interestingly, this phenomenon indicates that the Al-Fe-Mn rich precipitates along the grain boundaries in weld region are not so weak so as to lead a completely intergranular fracture (as in transverse welds), unless there is a co-existence of solidification cracks along with those precipitates (as in longitudinal welds). The longitudinal weld (weld section 1 in Fig. 24) is thin enough during final stage of failure. This has resulted in non-revelation of cleavage (type of signature of the overload) failure. This low thickness of the final zone of failure is due to the presence of the deep solidification crack of three-dimensional nature extending towards longitudinal weld periphery of the fracture surface at the component edge.

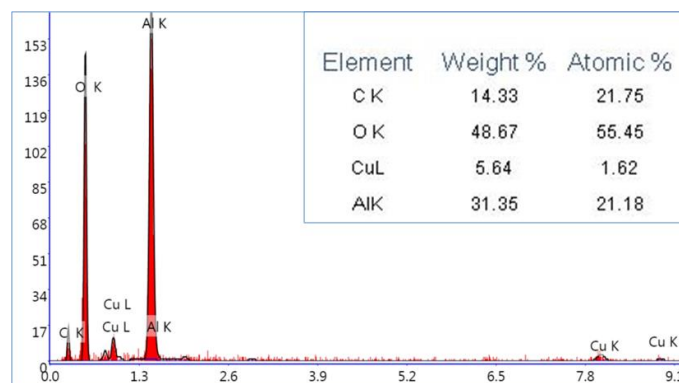
EDS analysis on the location marked as 1 (Fig. 5b) reveals the presence of Al and O majorly (Fig. 6). It basically reflects the composition of the tiny round particles present in that location. Fractographs near the weld region (along one of the side welds) are shown in Fig. 7. Again, HAZ in this region reflects intergranular fracture, while fracture of the weld zone is completely cleavage type. However, intergranular channels are even quite visible within this cleaved surface. Very prominent secondary crack has also been observed at the boundary or interface between the weld zone and HAZ.

Figure 6: EDS analysis pattern taken on location 1 (Fig. 5b)

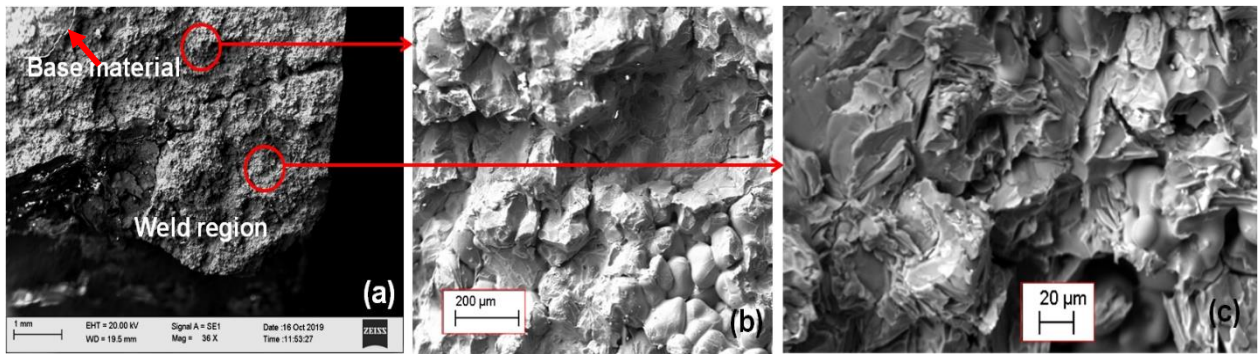
Figure 7: Fractographs near the weld region

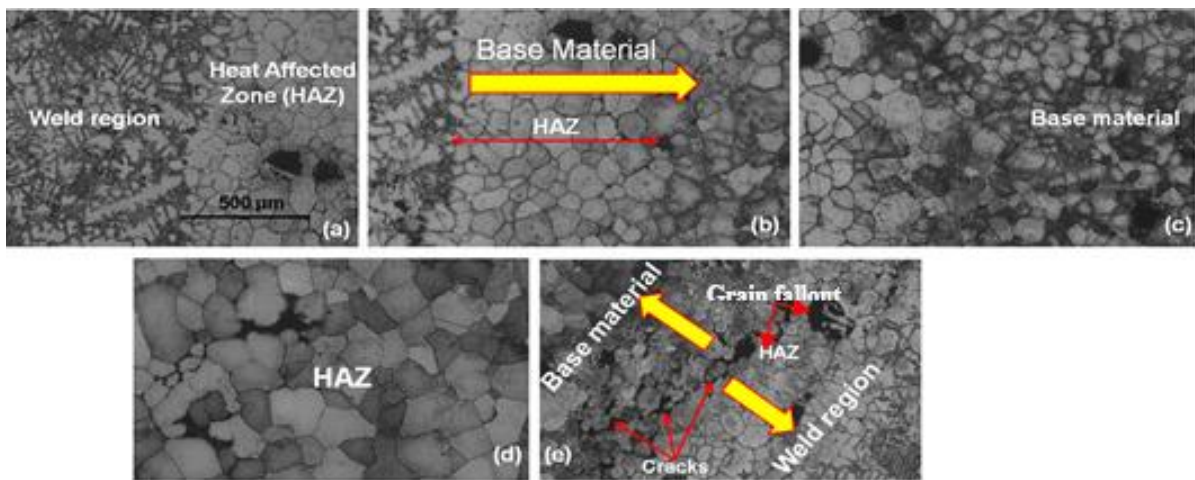
Microstructure exhibits the presence of well revealed weld zone and base material after etching (Fig. 10). Weld region contains few dendrites with 90° angle between primary and secondary dendritic arms indicating that the weld material is cubic. Interestingly, both the heat affected zone (HAZ) and remaining base material reveal the presence of equiaxed grains. Heat-affected zone (HAZ) of a spread of 0.7 mm has been found and contains numerous cracks and grain fallouts (Fig. 10). Low magnification SEM images are shown in Fig. 11. Ample of pores has been found in both the regions, i.e., weld as well as base material. Amount of pores seems to have been more in weld than that in the base material. High magnification images of the weld region and base material are presented in Fig. 12(a, b) and Fig. 12(c-e), respectively. Again, area fraction of the cracks is found to be more in case of weld region than that in the base material.

Figure 10: Optical microstructures of the towing arm end in etched condition

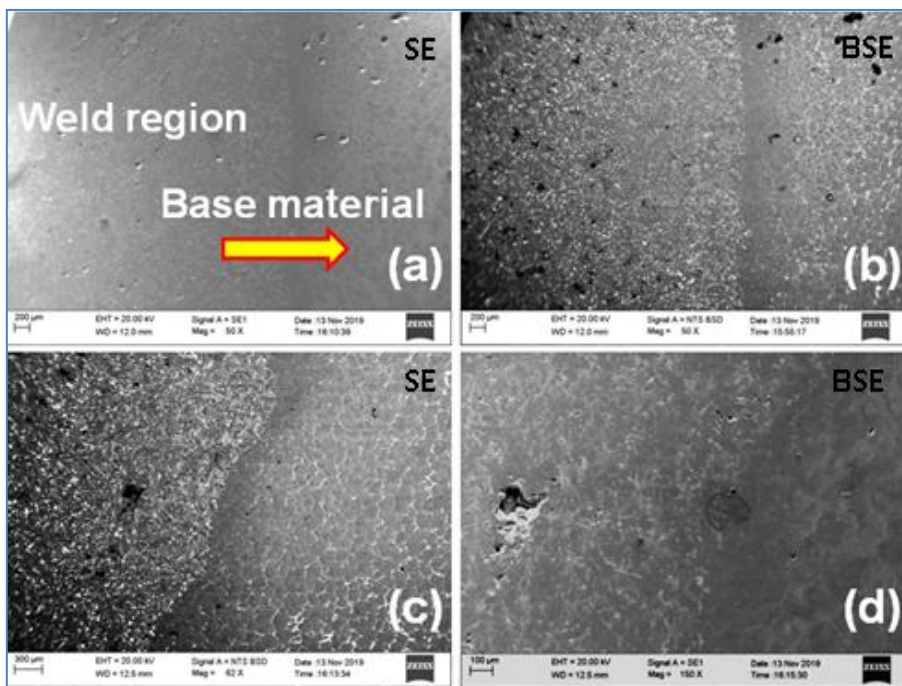
Figure 11: SEM micrographs of the towing arm end near the weld region

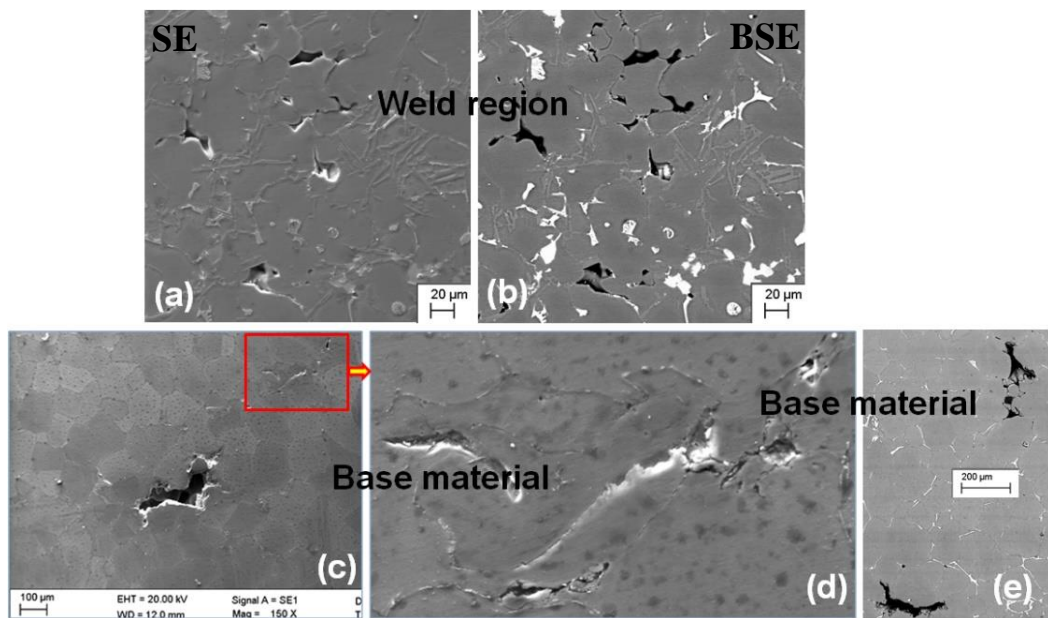
Figure 12: High magnification SEM images of the weld region and base material

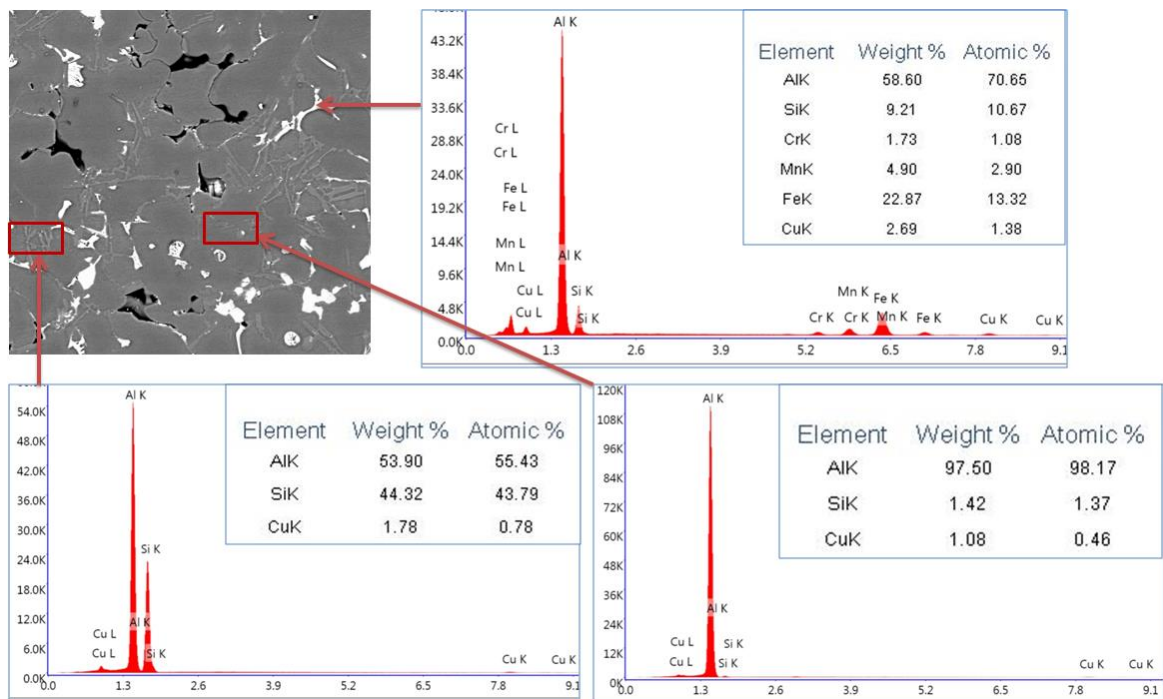
The EDS analyses on various phases in the weld zone are presented in Fig. 13. Some precipitates appear to reside along the grain boundaries have been found to be rich in Al, Fe and Mn. Eutectic phases contain mainly Al and Si. Overall composition of the weld region has been found to be rich in Si and Al (Fig. 14). Base material reveals the presence of grain boundaries rich in Cu, Fe and Al (Fig. 15). Defect portions of the grain boundaries contain Si, Cu along with Cl and O (Fig. 16). Overall base material composition shows the presence Al along with small amount of Cu (Fig. 17).

Figure 13: EDS analysis patterns on various phases in the weld zone

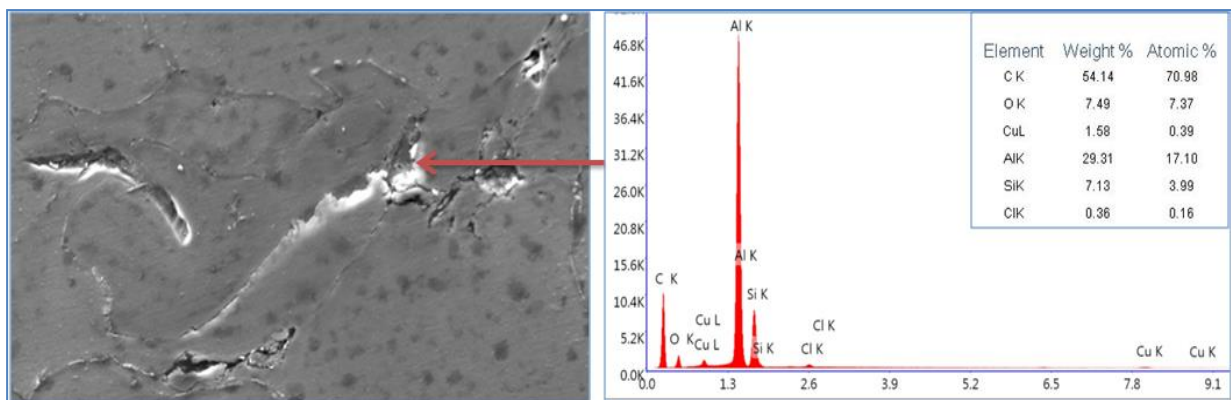
Figure 16: EDS analysis of defects on grain boundaries in base material

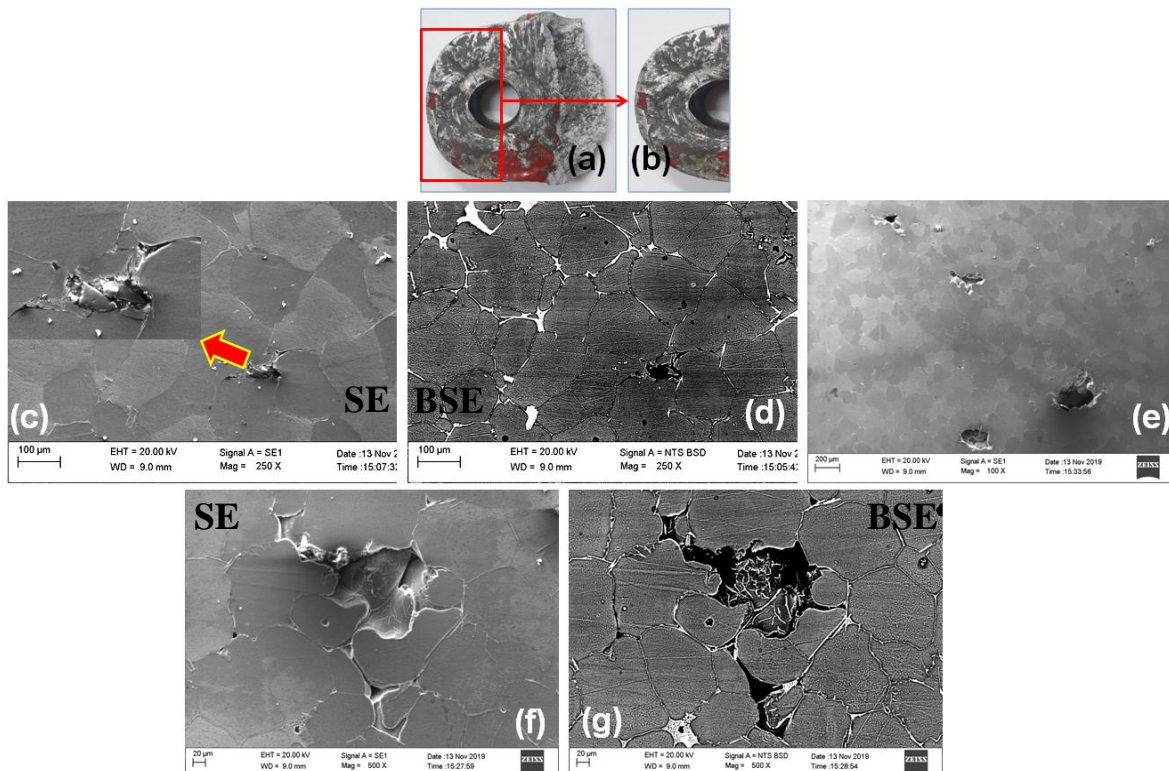
Fig. 18 exhibits SEM micrographs of various locations of the towing arm end away from the failed region. Reference image of sample extraction is displayed in Fig. 18(a, b). Presence of thick and continuous grain boundary precipitates are quite well revealed in the BSE images (Fig. 18(d, g)). Several microstructural defects related to grain boundary cracking and grain pullout have been observed. Fig. 19 exhibits high magnification image of the said region. Two types of precipitates have been observed: (i) rich in Cu and Fe and (ii) rich in Cu only. Matrix composition has been found to be Al containing ~ 5 wt.% Cu.

Figure 18: SEM micrographs of various locations of the towing arm end away from the failed region

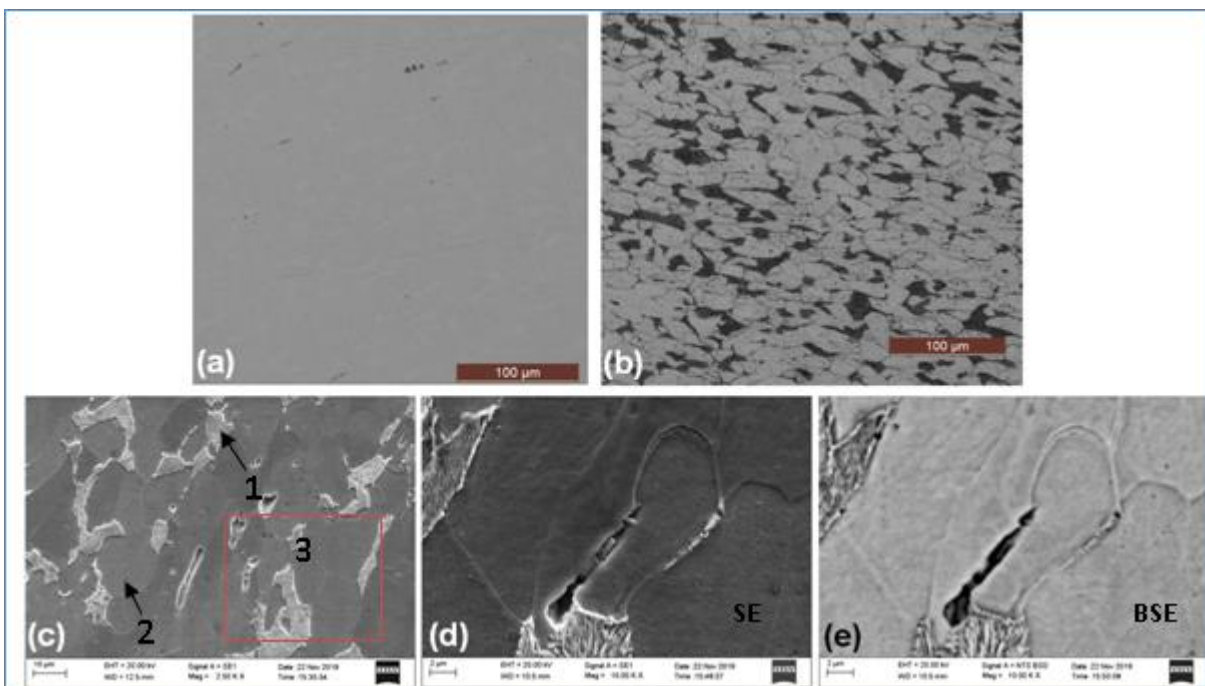
Microstructures of the towing pin are shown in Fig. 20. It reveals the presence of alternate layer of greyish and whitish phases. Three different locations marked as 1 (bright contrast), 2 (grey contrast) and 3 (overall composition) have been analyzed for composition. The EDS analysis reveals the presence of Fe only in all the three locations (Fig. 21).

Figure 20: Optical (a, b) and SEM micrographs (c-e) of towing pin

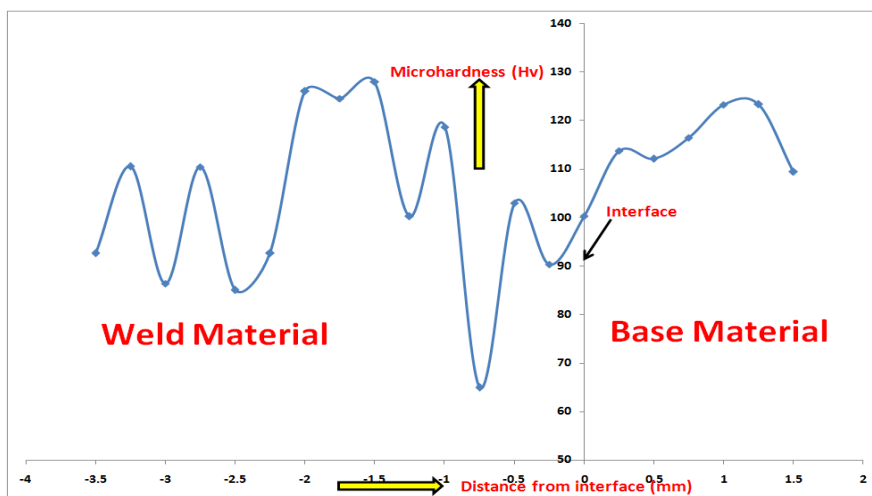
A micro hardness profile taken along a line across the weld interface and covering both base and weld materials has been shown in Fig. 22. Fig. 23 is the reference image for the indentations taken on the sample. Here, one can notice that the weld material possesses an average hardness value of 102 Hv, while the same for base material is 116 Hv. It may be noted that these values are not in agreement with the bulk Vickers hardness values of the two regions as mentioned above.

Hardness value of the interface (measured on the actual interfacial line) is found to be around 100 Hv. The hardness value on the weld side ranges from 65 to 130 Hv and gets stabilized at around 2.25 mm (2250 μm) from the interface. On the other hand, hardness value spanned from 115 Hv to 125 Hv on the base metal side and gets stabilized at around only 1.5 mm (1500 μm) from the interface.

Figure 22: Micro hardness survey (in Vickers scale) across the weld interface

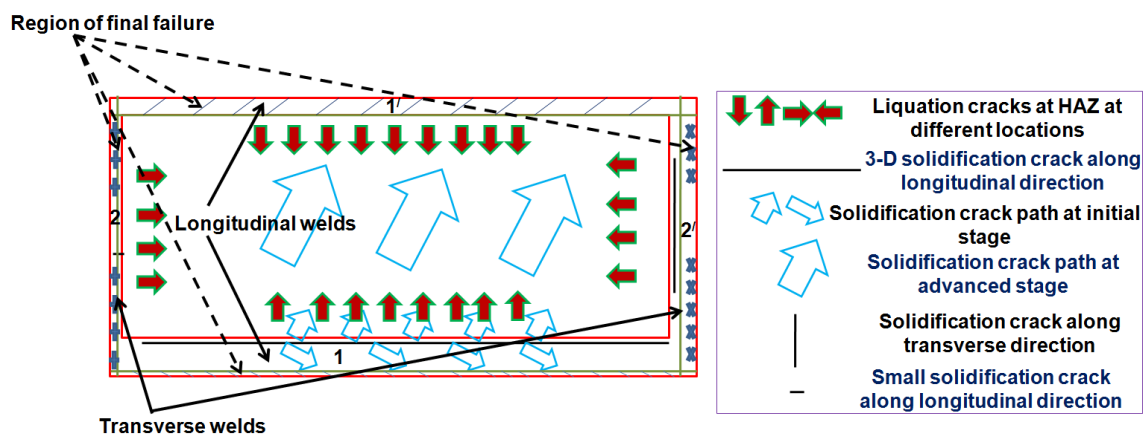
Schematic diagram consisting of a proposed sequence of events is shown in Fig. 24. This (Fig. 24a) is described with reference to the whole fracture surface presented in Fig. 3h. Longitudinal three-dimensional crack front spanning the whole length of the weld, close to fusion line is formed as a result of residual stresses coming out of joint constraint and/or heat treatment. This has disturbed the integrity of the joint and thus the component at the beginning of its service operation. This crack front has a curved surface area and extends from location at considerable depth to its opening up at the obtained fracture surface. This, later on, moves towards (both upward and downward) transverse directions (marked as inclined arrows) on the presently obtained plane of fracture surface. Advanced stage of its propagation on the fracture plane is indicated by big inclined arrows. On the other hand, material becomes weakened by the presence of liquation cracks in HAZ (indicated by small straight arrows). Thus, these liquation cracks indirectly have assisted in the present failure by easing the crack propagation stage. Similarly, small (longitudinal) and moderately big (transverse) solidification cracks in transverse welds have assisted the current failure by weakening the microstructure. Varying proportions of the final stages of failure are observed in transverse and longitudinal welds. Weld section 1 is proposed to possess the least area fraction of the final stage of failure. This is due to the consumption of its greater amount by the above said three-dimensional solidification crack front. This is much commensurate with the visual examination (Fig. 3) as well as with the fractographic evidence (Figs. 5 and 7).

Figure 24: Schematic diagram showing a proposed sequence of events leading to failure

Surrounding fixtures during welding operation has an effect in the present case of weld cracking. Solidification cracks have been observed at welds close to the fusion lines at both the longitudinal as well as the transverse sides. Small solidification cracks aligned along the major axis (i.e., along the longitudinal side on the fracture plane) are also observed within the weld. It is quite clear from the results reported so far, that there has been a dominance of transverse stress over its longitudinal counterpart, as is supported by the frequent occurrence of (solidification) cracks of considerable depth and length, aligned along the longitudinal side. The proposed schematic also corroborates the same in the primary fracture plane which is formed by the movement of longitudinal solidification crack front towards the transverse direction only (Fig. 24).
