Effect of Temperature on Penetration of Test Liquid into Boiler Pipe

Zaenal Abidin, Setyo Aji Wisnu Wibowo, Tasih Mulyono, Erry Yulian T. Adesta and Agus Geter Edy Sutjipto

ABSTRACT

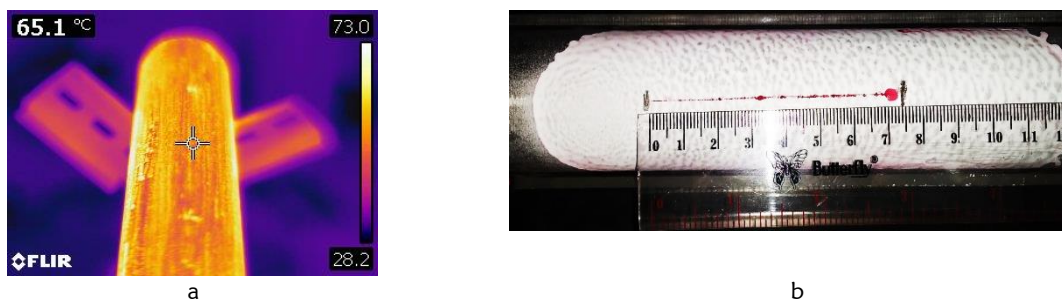
Figure 5: (a) Material image from the Flir camera (b) Defects produced at a surface temperature of 65.1 °C.

Then the last test was carried out at 65 °C as shown in Figure 5a. The flir camera image at the spot point shows a temperature of 65.1 °C and a range of 28.2° C –73.0 °C. Almost the same as testing at a temperature of 50 °C to 60 °C, namely the penetrant liquid evaporates. But at a temperature of 65.1 °C, the evaporation is higher, which is marked by the amount of smoke produced. Likewise, when the developer liquid is sprayed onto the surface of the test material, this liquid dries immediately and briefly lifts the penetrant. All of this results in the output that is a thin red line and a single dot to the right of the image. When compared with the results of radiographic images of these defects do not identify actual defects.

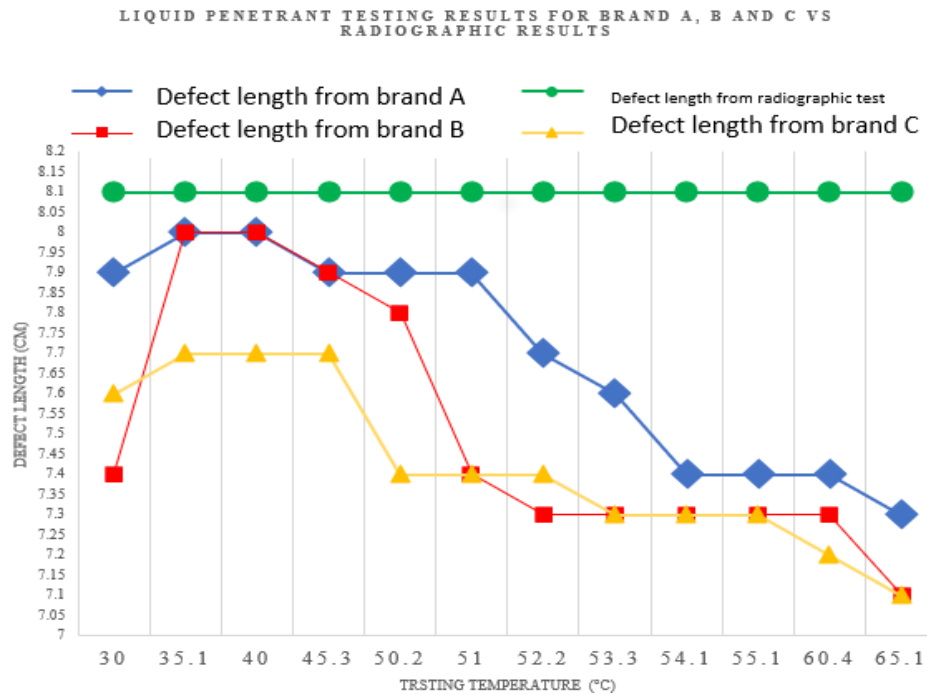
Figure 10: Graph comparison of liquid penetrant test results for brands A, B and C with radiography results

The radiographic test results show an 8.1 cm long defect image shown in Figure 4.13 which is marked with a green line. The length of this defect is the reference for determining the image of the defect produced in the liquid penetrant test. Defective images resulting from the penetrant test are said to be good if they approach the length of the defects resulting from the radiographic test. Based on Figure 10, it can be seen from the test results that the best liquid penetrant is brand A with all temperatures applied producing a length close to the length of the radiographic test results.

1. The best temperature has been obtained for testing superheater tube boilers using the NDT (liquid penetrant testing) method brands A, B and C, namely at 40 oC, with the thickness and length of the penetrant that appears to the surface according to the actual defect and close to the image of the radiographic test results.
2. The results of liquid penetrant tests for brands A, B and C above 52 oC have a thickness and length that do not match the original defects, so they should not be done because they could indicate fake defects.
