Failures of Flexible Diaphragm Couplings of Power Take Off (PTO) Shafts of an Aircraft by Surface Discontinuity, Controlled by Stress Concentration or Stress Intensity Factor

Mrityunjoy Hazra and Satyapal Singh

Failures of two power take off (PTO) shafts of an aircraft have been analysed. Two shafts, one each developed by two different manufacturers failed separately during power run endurance test conducted at room temperature and ambient normal atmosphere. In both the cases, cracks were observed on the outer diaphragm disc. One shaft showed cracking in the engine side, while the other one exhibited cracks in the aircraft mounting accessory gearbox (AMAGB) side. Chemical analysis, microstructure and hardness evaluation indicate that the diaphragm material of the shafts is Ti-6Al-4V alloy used in solution treated and aged condition, as per the desired specification AMS 4928. Microstructural in-homogeneity, possibly a result of improper forging, was observed in diaphragm material of both the shafts. Additionally, surface discontinuities induced by forging and subsequent insufficient machining were noticed on the diaphragms. The diaphragms failed by fatigue with cracks possibly nuc

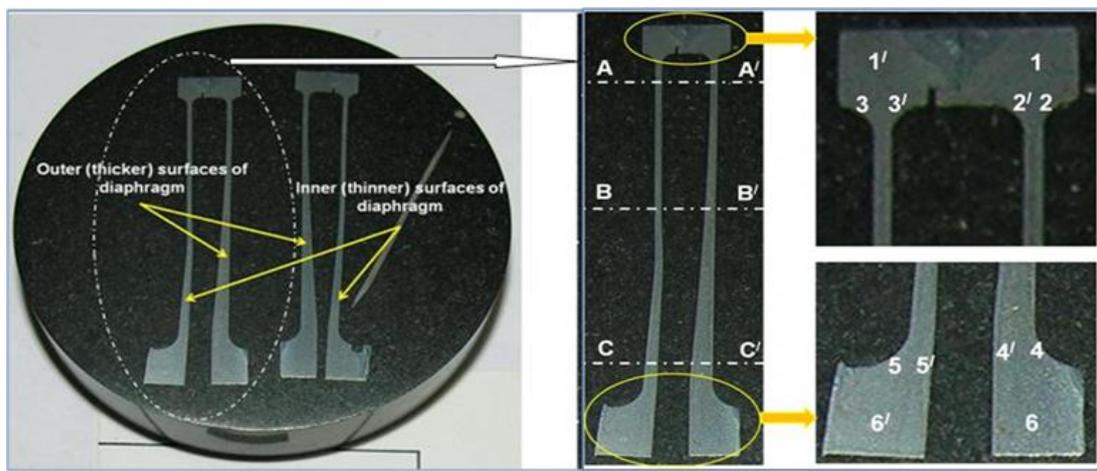
Representative hardness values were taken at different locations on transverse thick and thin sections of the diaphragm discs of the shafts. There is no difference in hardness values at different locations on the whole diaphragm cross sections. Fig. 9 is the reference figure for hardness evaluation marking typical indentation locations on both thick and thin sections of diaphragms of both the shafts. Hardness profiles along random locations like along A-A', B-B' and C-C' were also taken. Average hardness values in diaphragms in both the cases are found to be around 335 HV.

Fig. 9: Cross-sectional profile of inner and outer diaphragms of engine and AMAGB ends (marked points are for microstructure and hardness evaluation).
