Failure Investigation on Failed Towing Arm of an Aircraft: A Case of Improper Material Processing and Failed Repair Welding of a Cast Al-Cu-Si Type Aluminium Alloy

Mrityunjoy Hazra and Ashok Kumar Singh

M. Hazra ✉, A. K. Singh
Defence Metallurgical Research Laboratory (DMRL)P.O. Kanchanbagh, Hyderabad 500 058, India
E-mail: mhazra@dmrl.drdo.in

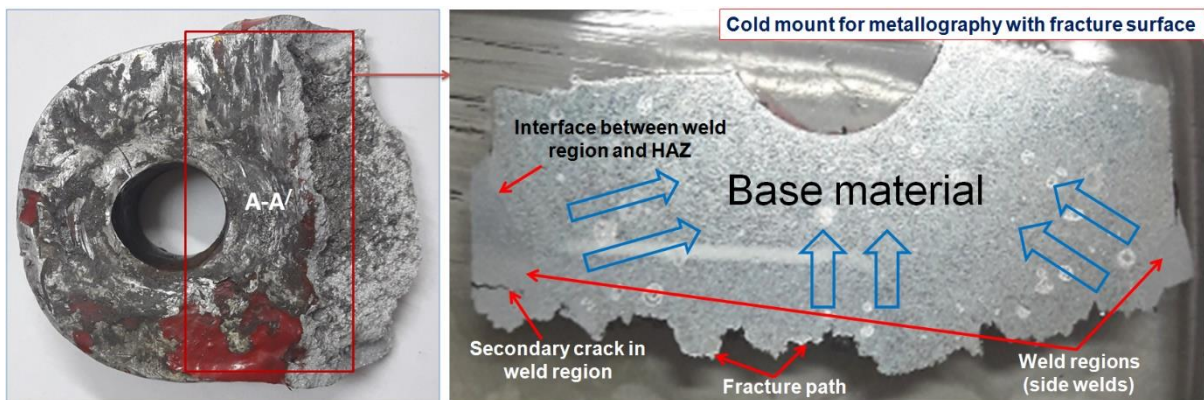
Figure 8: Cold mount containing towing arm fractured end along with location of the sample in main fractured piece

Towing arm fork (henceforth, it will be referred to as towing arm only) fractured section mounted in cold mount along with the schematic view of the location of the sample in main fractured piece is shown in Fig. 8. Existence of weld regions at two sides or edges is very clear. This image may be seen along with the as-received photographs presented in Fig. 3(a, d-f), so as to have quite a good idea about the relative location of the weld, HAZ and base material within the fractured component. It has also been found to contain secondary cracks intermittently, as one such is marked in Fig. 8b. It is to be noted that the crack trajectory and orientation of secondary cracks is exactly matching with the fracture path (main crack causing the fracture) (Fig. 8). Grain boundary precipitates and occasional cracking along these precipitates have been observed throughout the base as well as weld region in the un-etched condition (Fig. 9).

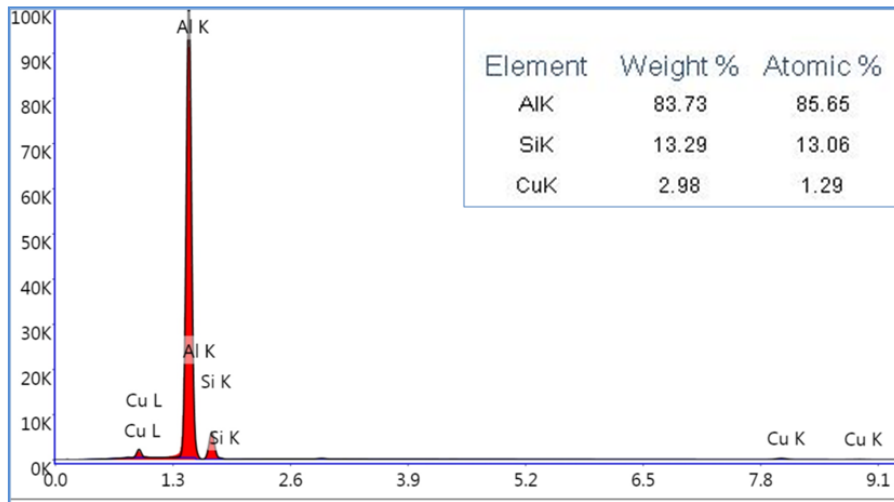
Figure 14: Overall composition of the weld region as obtained by EDS analysis

The EDS analyses on various phases in the weld zone are presented in Fig. 13. Some precipitates appear to reside along the grain boundaries have been found to be rich in Al, Fe and Mn. Eutectic phases contain mainly Al and Si. Overall composition of the weld region has been found to be rich in Si and Al (Fig. 14). Base material reveals the presence of grain boundaries rich in Cu, Fe and Al (Fig. 15). Defect portions of the grain boundaries contain Si, Cu along with Cl and O (Fig. 16). Overall base material composition shows the presence Al along with small amount of Cu (Fig. 17).

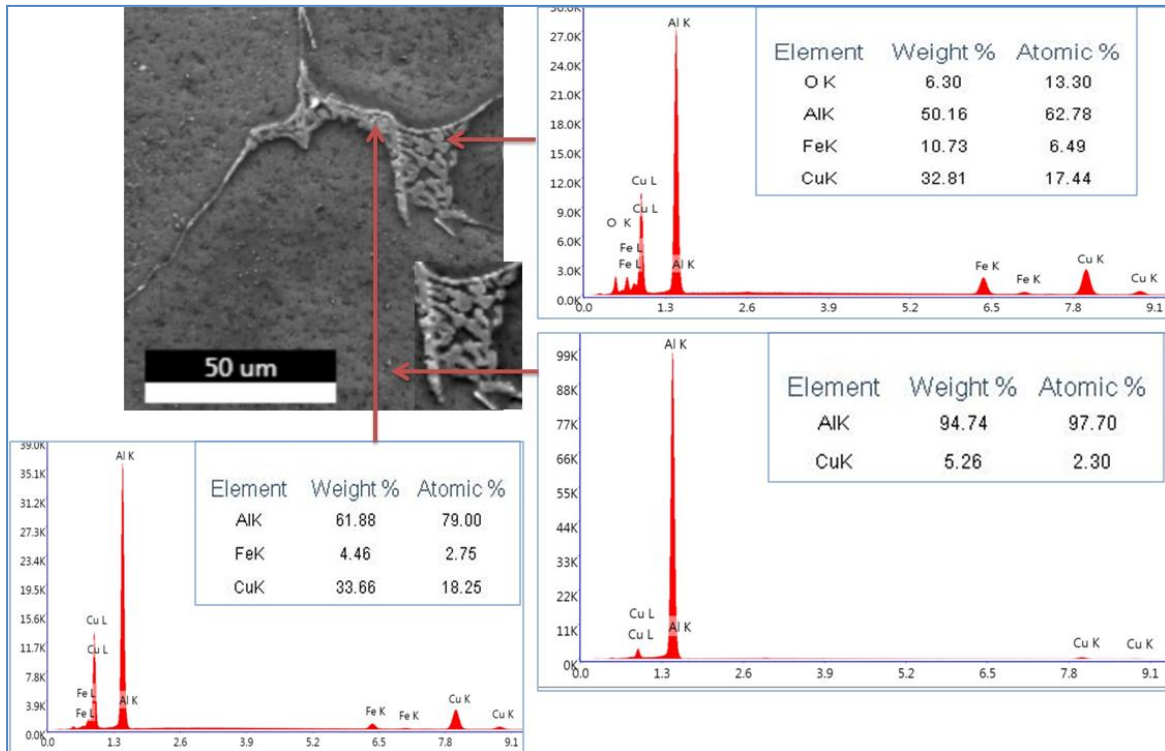
Figure 19: High magnification image along with EDS analysis on regions (Fig. 18)

Fig. 18 exhibits SEM micrographs of various locations of the towing arm end away from the failed region. Reference image of sample extraction is displayed in Fig. 18(a, b). Presence of thick and continuous grain boundary precipitates are quite well revealed in the BSE images (Fig. 18(d, g)). Several microstructural defects related to grain boundary cracking and grain pullout have been observed. Fig. 19 exhibits high magnification image of the said region. Two types of precipitates have been observed: (i) rich in Cu and Fe and (ii) rich in Cu only. Matrix composition has been found to be Al containing ~ 5 wt.% Cu.

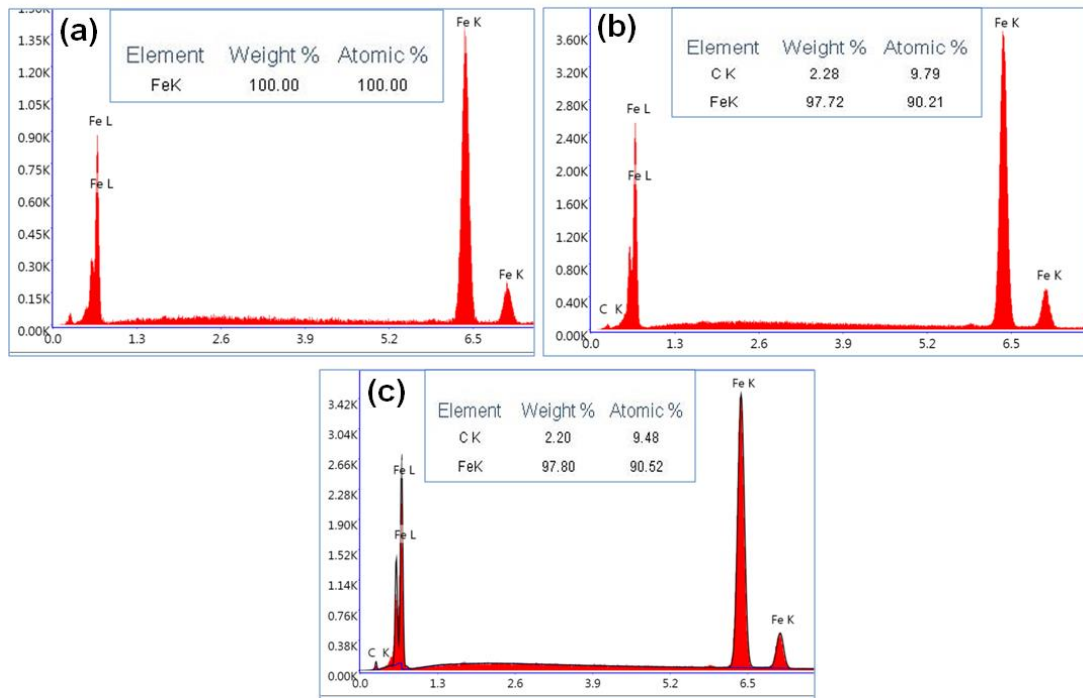
Figure 21: EDS analysis patterns on various marked locations 1, 2 and 3 (Fig. 20)

Microstructures of the towing pin are shown in Fig. 20. It reveals the presence of alternate layer of greyish and whitish phases. Three different locations marked as 1 (bright contrast), 2 (grey contrast) and 3 (overall composition) have been analyzed for composition. The EDS analysis reveals the presence of Fe only in all the three locations (Fig. 21).

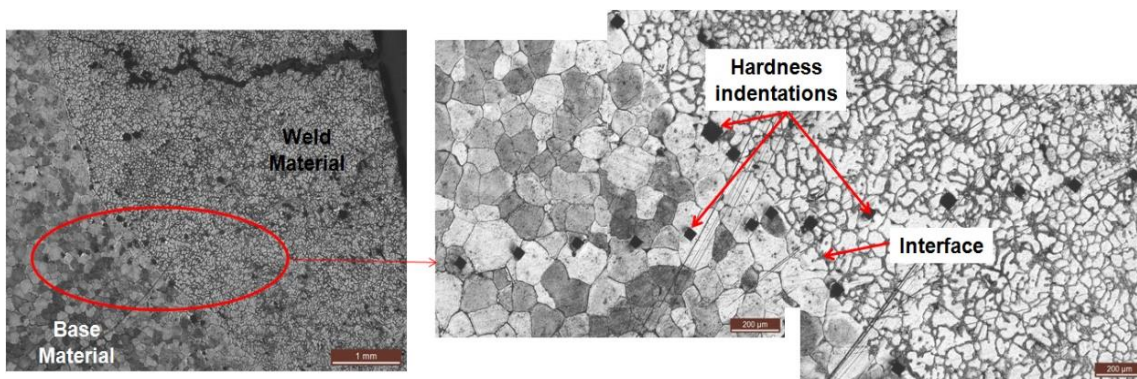
Figure 23: Reference image for the micro hardness survey across the weld interface

A micro hardness profile taken along a line across the weld interface and covering both base and weld materials has been shown in Fig. 22. Fig. 23 is the reference image for the indentations taken on the sample. Here, one can notice that the weld material possesses an average hardness value of 102 Hv, while the same for base material is 116 Hv. It may be noted that these values are not in agreement with the bulk Vickers hardness values of the two regions as mentioned above.
